Failure of the SS520 No. 4 experiment and measures to be taken

13 February 2017

Institute of Space and Astronautical Science

Japan Aerospace Exploration Agency

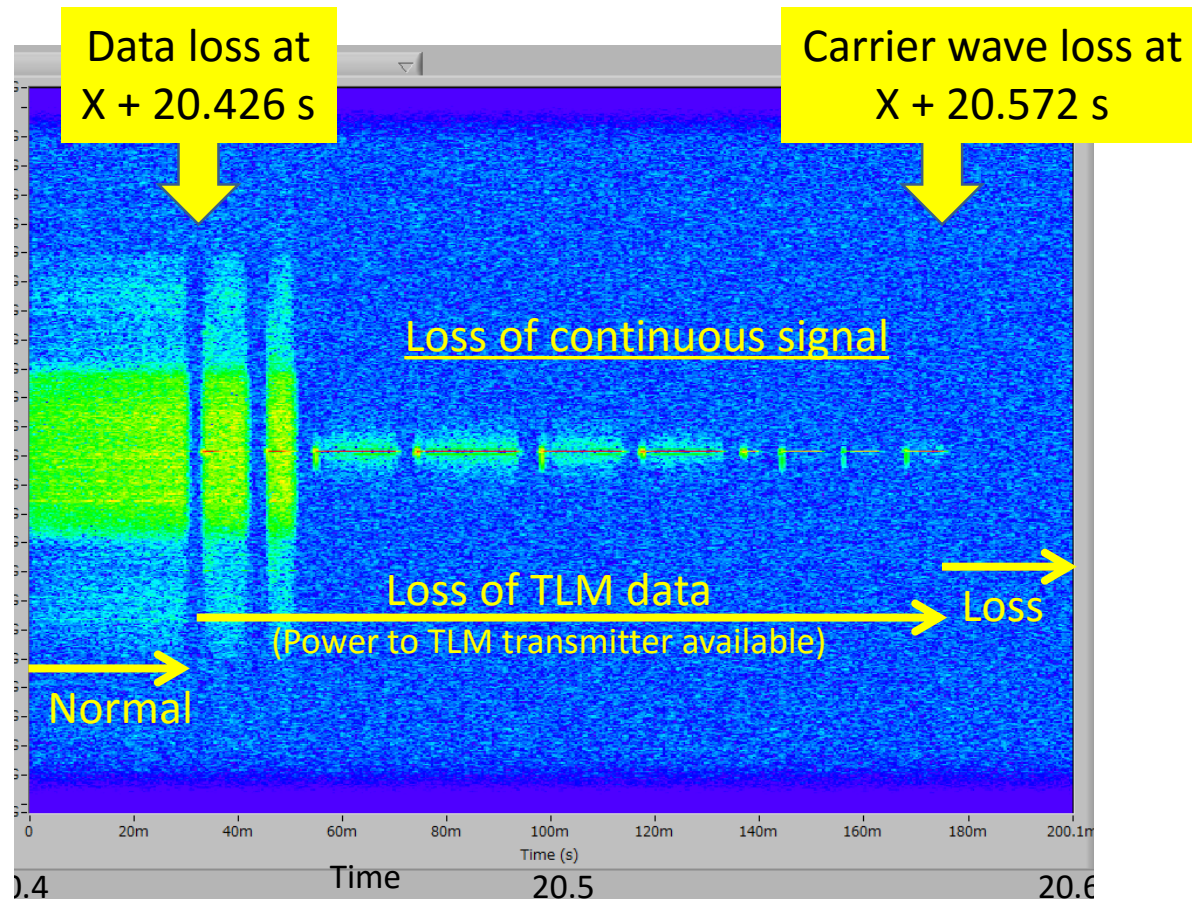
Received status of transmitted radio waves around X + 20.4 to 20.5 s

X-relative time [s]	Device showing anomaly	Phenomenon
X+20.015–20.020	2nd stage motor strain sensor	Anomalous output value. Sensor power supply system broken or ground fault (from analysis results).
X+20.426	TLM transmitter	Ten short interruptions of about 3 ms each occurred. Period between interruptions was 14.5 ms on average.
X+20.446	TLM transmitter	Data transfer interruption
X+20.572	TLM transmitter	Transmission interruption (lock off)
X+20.831	CMD	100% answer-back errors

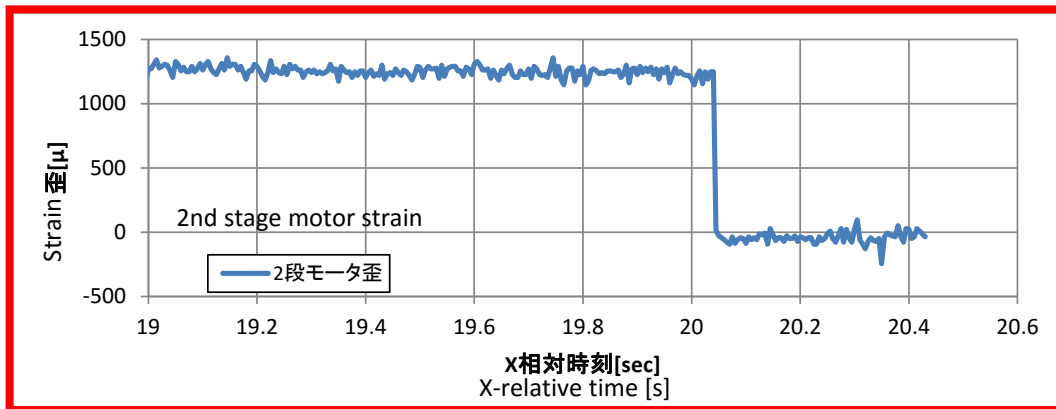
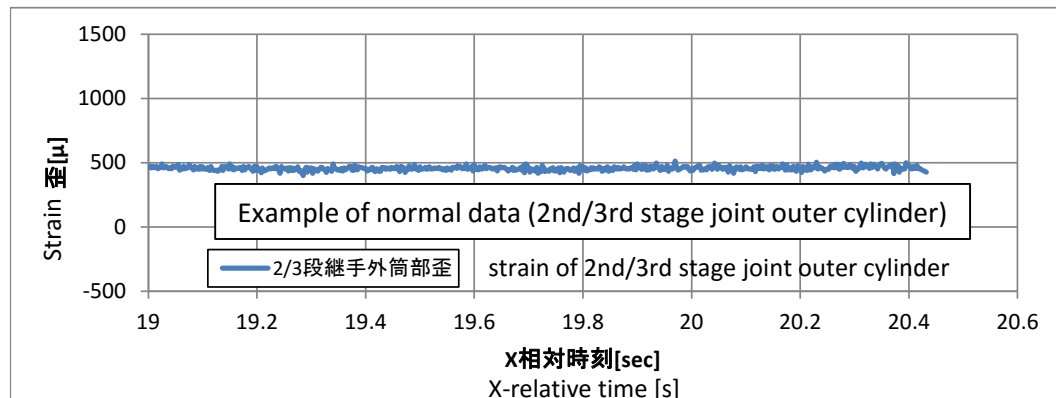
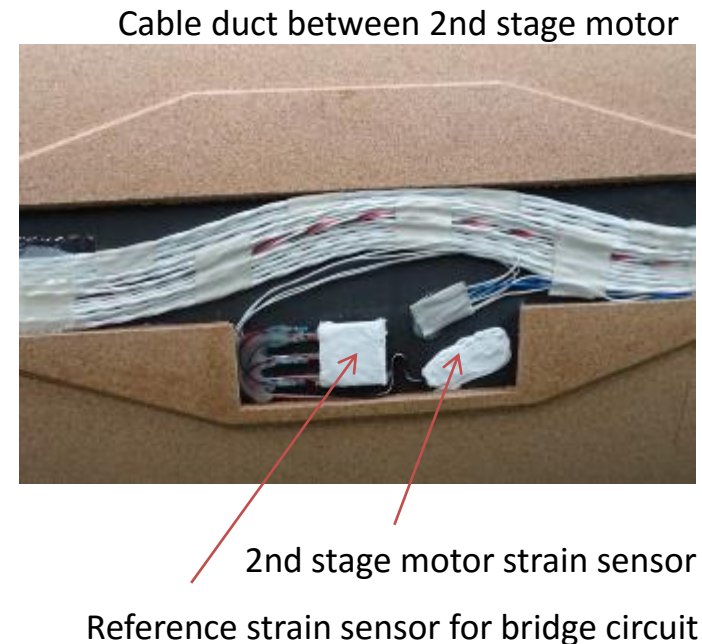
2-3. Output anomaly of 2nd stage motor strain sensor

Recognized as necessary data for relation with other phenomena due to time proximity (X+20.015 to 20.020 s) to TLM data loss (X+20.426 s).

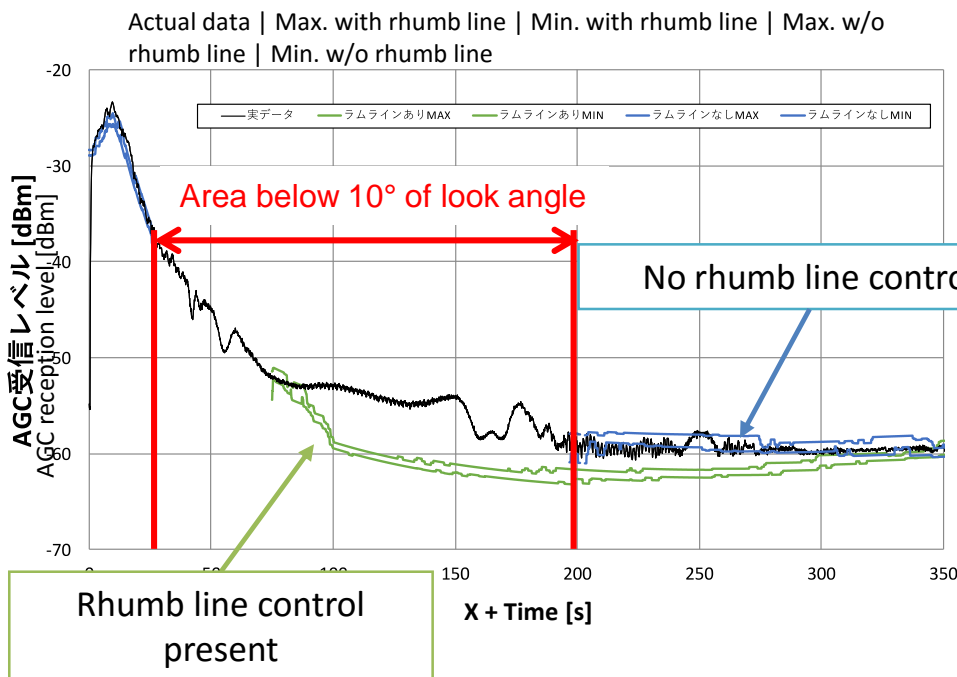
Miyabaru Precision Radar

Flight data agree with the finding that attitude change by rhumb line control did not occur.

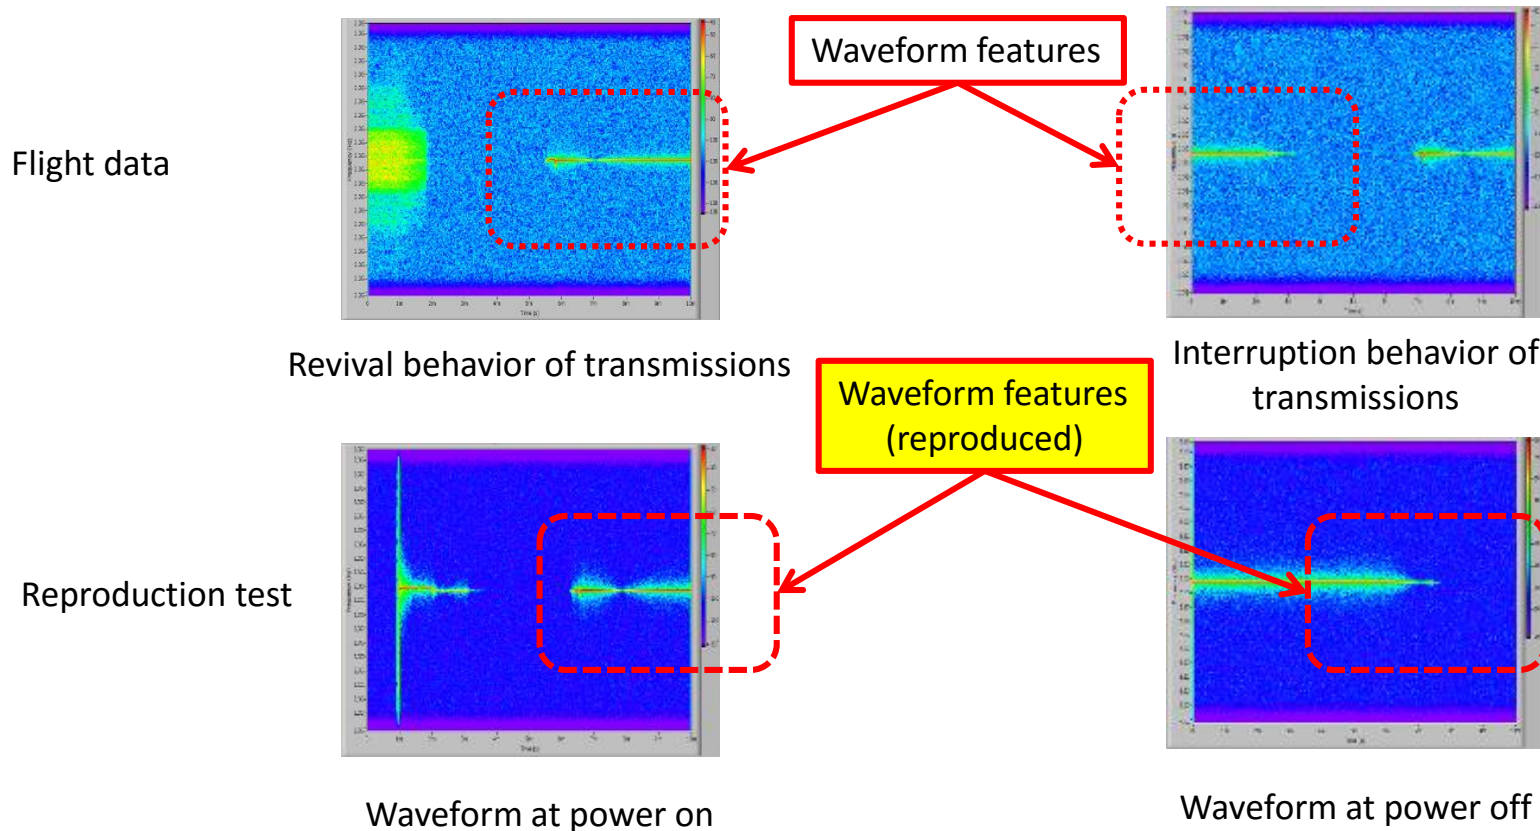
Based on features seen in the flight data, we investigated the spectrum waveform at TLM transmitter power ON/OFF.

From the appearance of the reproduced spectrum waveform, it is possible that TLM transmitter power supply input was continuously intermittent.

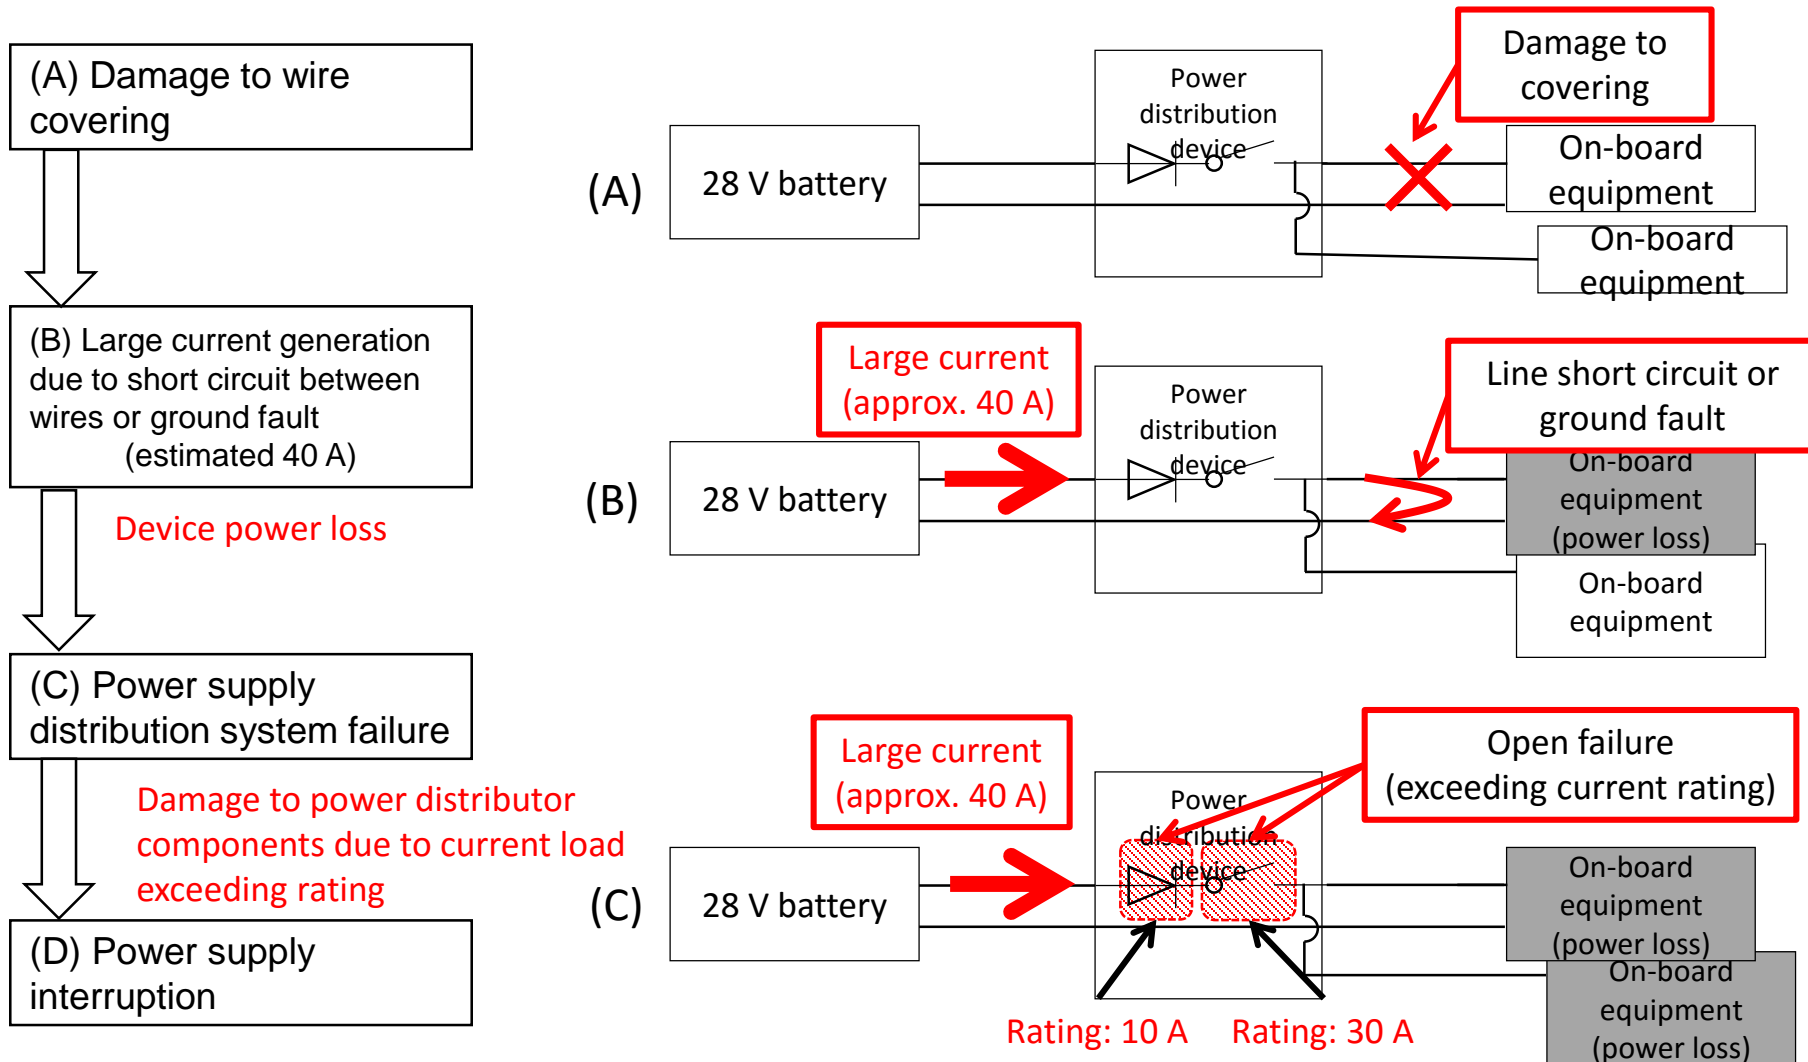
4-1. Estimated mechanism of power supply anomaly

From the FTA-based factor investigation, the mechanism leading to the power source anomaly is estimated as follows.

⇒ (D) As a result of a short circuit, a component failure or disconnection in the power distribution device occurred, eventually disconnecting the power supply function.

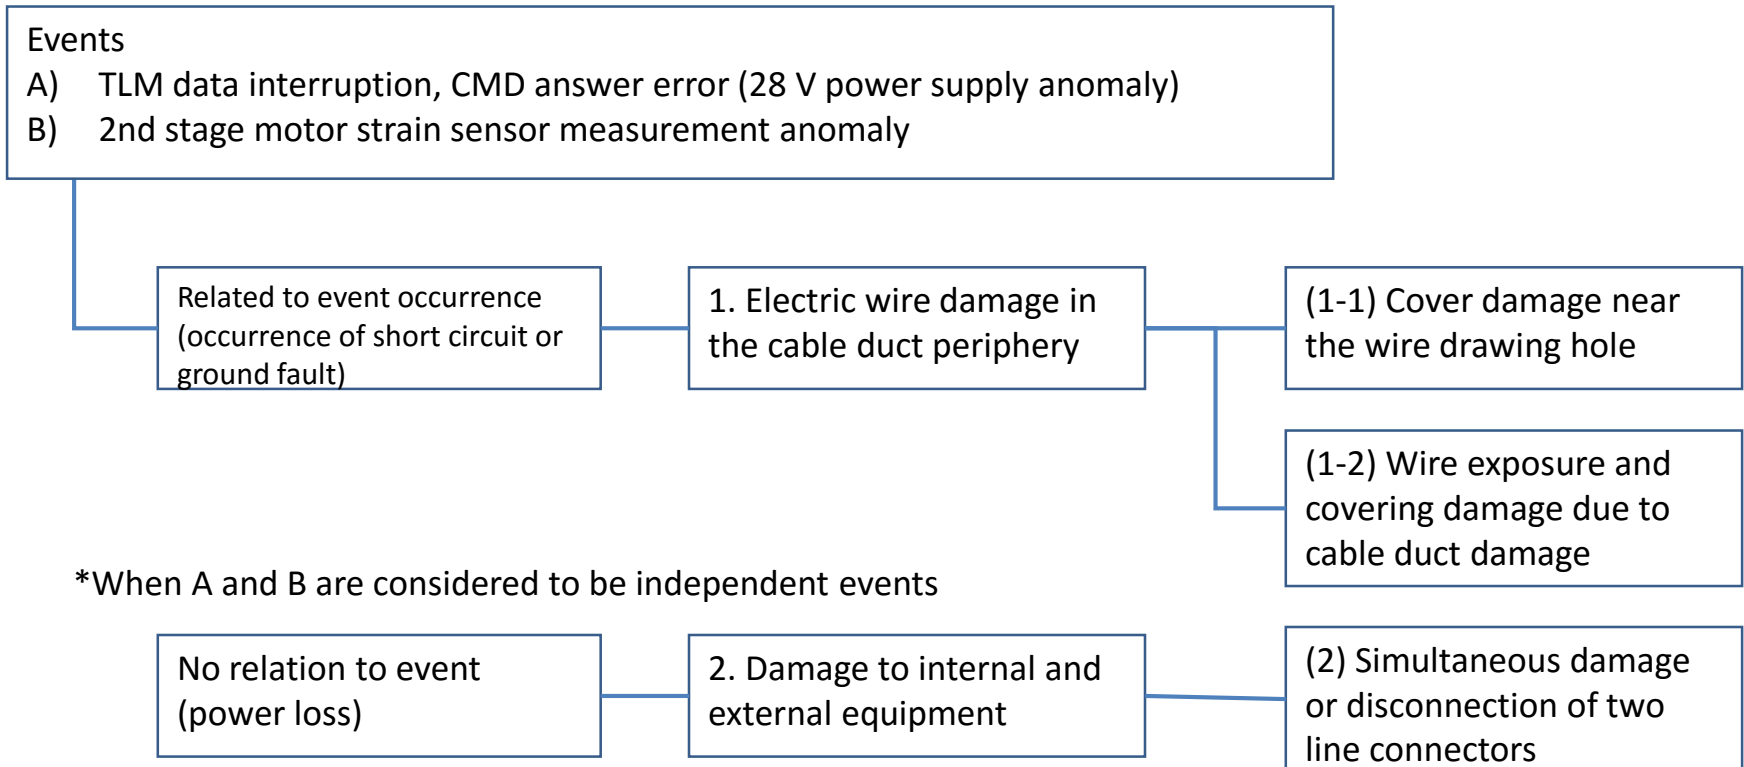
4-2. Estimation of causes

From the confirmed events and the occurrence factors extracted by FTA, **we estimate the damaged part and causes to be as follows, considering the relevance of the occurring events.**

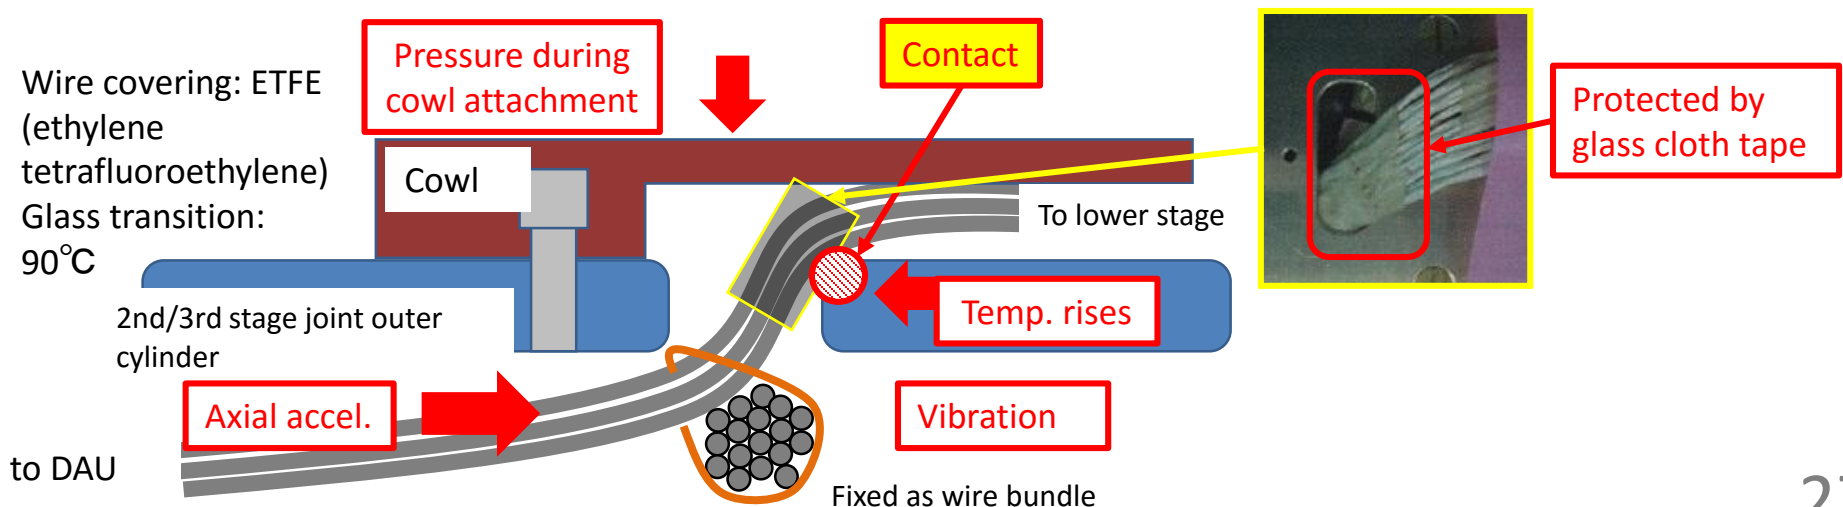
4-4. Probable cause (1)

Short circuit due to wire cover damage at the wire drawing hole.

- The electric wire attached near the wire drawing hole (at the upper part of the cowl) was influenced by acceleration in the direction of the vehicle axis and by spacecraft vibration during flight, causing the surface cover on the electric wire to experience friction.

- The periphery of the wire drawing hole was heated by aerodynamic heating, and the temperature of the metal (aluminum) part increased.
- As a result, the wire covering was damaged due to a combination of effects:

- Contact between the electric wire and metal structure by pressing force during cowl attachment
 - Static load due to axial acceleration
 - Friction due to spacecraft vibration

- Difference in the degree of temperature rise in the wire contact area (*Changed to aluminum in No. 4)
 - Differences in covering protection measures from previous unit (* Changes in hole position and cowling shape from No. 4)

- As a result of the above effects, core wires of the 28 V power supply system were exposed and a wire with a damaged covering contacted the metal structure, resulting in a short circuit.

- (1) Countermeasures against damage to the wire covering (probable cause 1-1)
 - With regard to wire drawing holes, we will review the position, shape, etc. based on past results and improve reliability.
 - We will update the design to avoid direct contact between the wire and metal parts. Friction tests, etc. of the relevant part will be carried out beforehand to confirm protective effects.
 - As further measures to improve reliability, we will improve electric wires, covering materials, and protective construction to increase friction resistance.
- (2) Countermeasures against cable duct damage (probable cause 1-2)

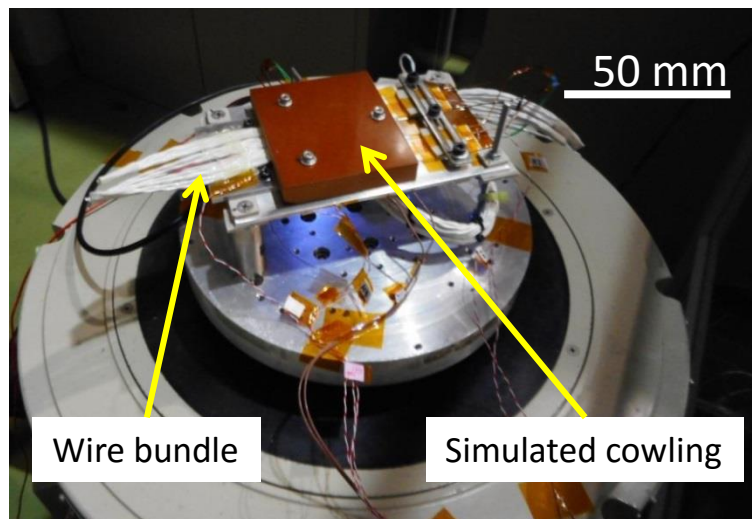
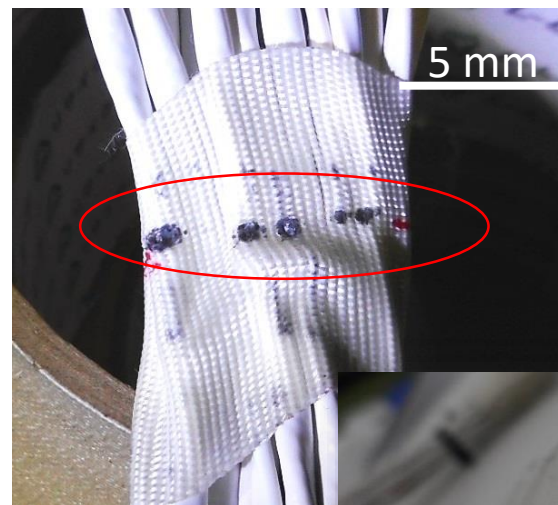
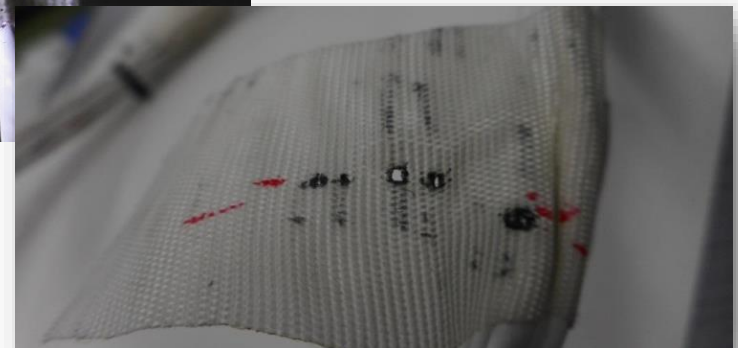
Reference: Electric wire friction tolerance test 1

Purpose: Confirmation of friction durability of electric wire coatings in contact with the wire drawing hole.

Implementation: The test is conducted under environmental conditions with temperature and vibration simulating the flight environment.

Results: Damage to the glass cloth tape (mainly contacting parts) used to protect electric wire coverings

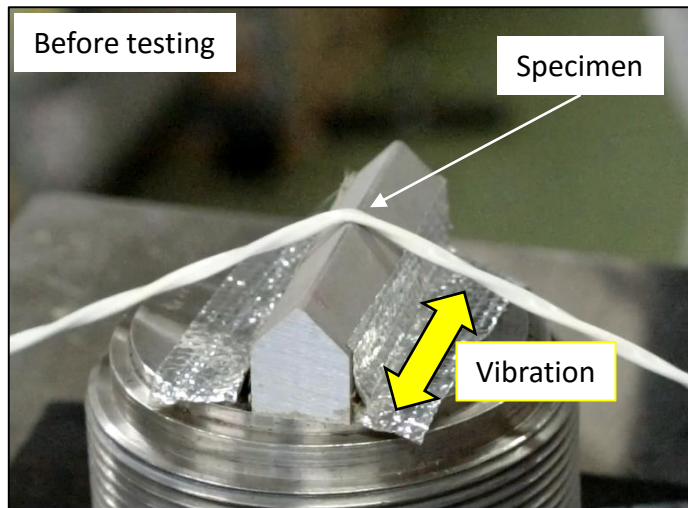
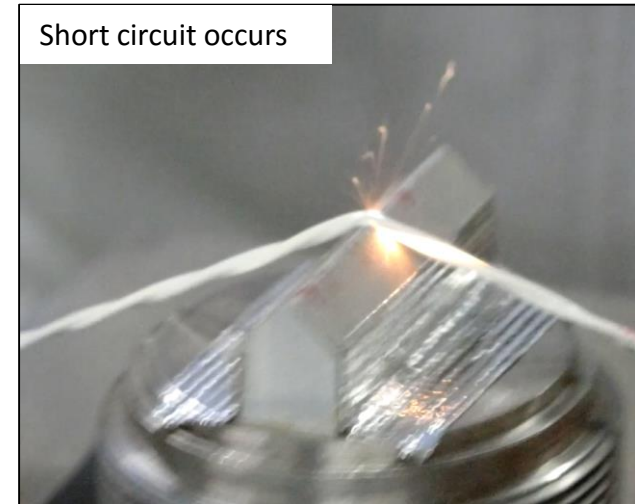
Reference: Electric wire friction tolerance test 2

Purpose: Confirmation of friction resistance of aluminum material and electric wire covering simulating a contact area

Implementation: Crossing an electric wire coating on a curved contact surface and moving the contact part at constant speed and amplitude to apply friction to the coating, we confirmed the occurrence of a short circuit.

Results: A short circuit occurred at a total friction distance equivalent to the actual equipment that was assumed.
