Failure of the SS520 No. 4 experiment and measures to be taken

13 February 2017

Institute of Space and Astronautical Science

Japan Aerospace Exploration Agency

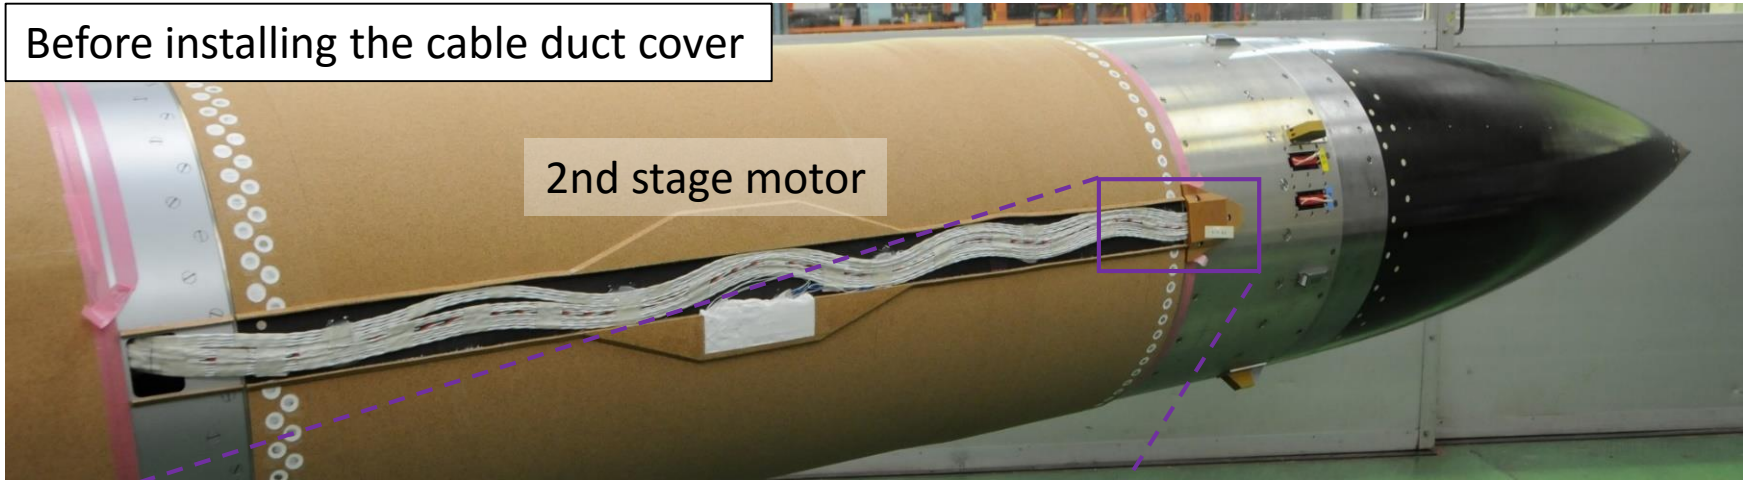
Before installing the cable duct cover

- Because it is necessary to lay electric wires outside the 2nd stage motor casing, those wires are protected against the flight environment (acceleration, aerodynamic force, and aerodynamic heating).

(1 - 1) Cover damage near the wire drawing hole

- The electric wire bundle is pressed against a corner of the relevant part under the influence of acceleration.
- In No. 4, the metal structure was changed from stainless steel to aluminum, which has a thermal conductivity about 10 times higher.

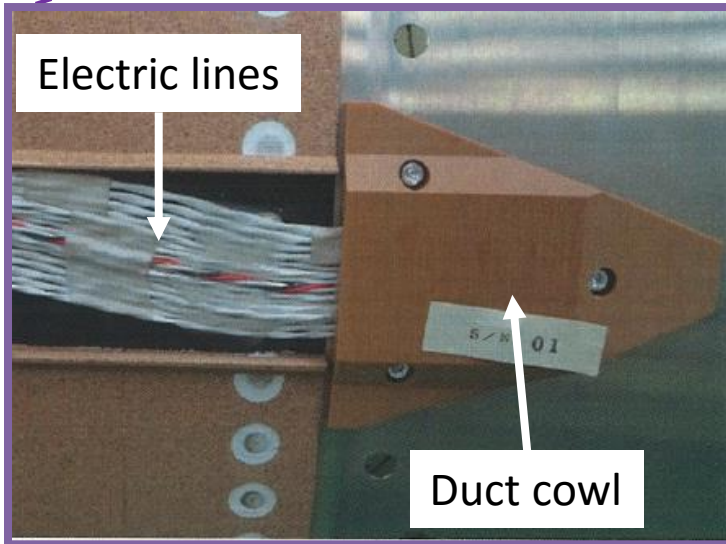
Electric lines

(1 - 2) Wire exposure and covering damage due to cable duct damage

- The part is molded with a cork sheet, and there is a possibility that the electric wire will be exposed if it breaks.
- The part is directly subjected to aerodynamic influences (airflow, aerodynamic heating, etc.) during flight.
- In No. 4, design changes to the cable duct (addition of a cowl, removal of internal filler) were carried out for weight reduction and reduction of aerodynamic drag.
- Unusual fluctuation was observed in the pressure monitor (fluctuation in the measurement range is small and the noise is large, so it is difficult to judge the relevance to the event)
